# Tube Bundle Fires at ETTP

## *An Historical Retrospective*

Brenda Hawks, DOE-ORO

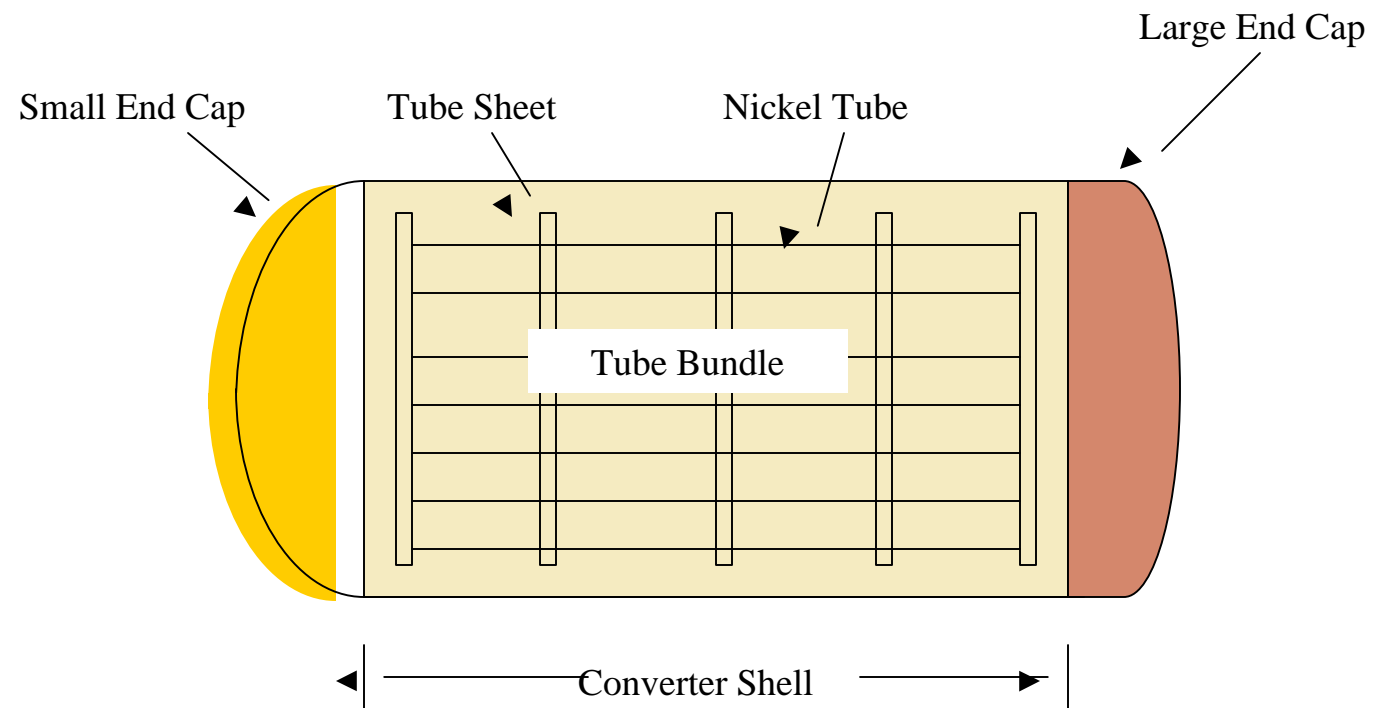
# Simplified Converter

- ✍ Converters consist of an outer steel shell, two end caps and an interior tube bundle
- ✍ A tube bundle consists of thousand of nickel tubes held in place by circular tube sheets
- ✍ Converters are dismantled in the K-33 D&D workshop

- ✍ **Dismantlement of converters began in 1999.**
- ✍ **Process consists of the following:**
  - Small end cap removal
  - Large end cap removal
  - Removal of tube bundle
  - Dismantlement of tube bundle
